Thermal History Paint case study

Nozzle Guide Vane Segment of small aircraft engine

Results on the Nozzle Guide Vane Segment

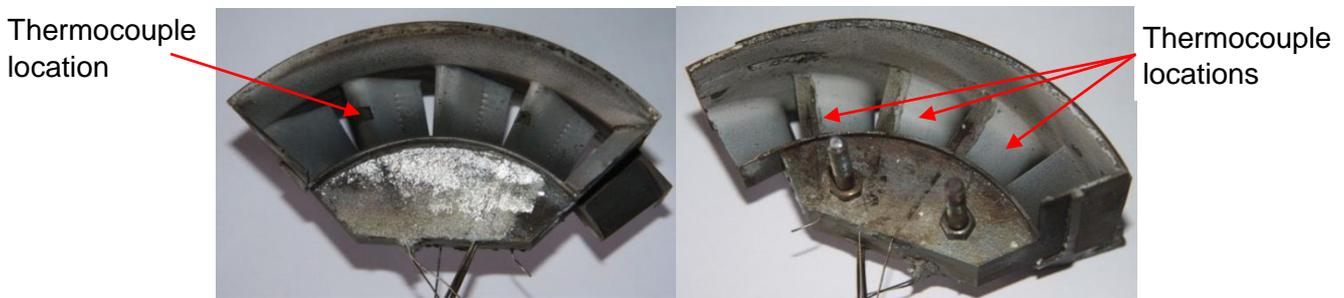
Figure 2. A photograph of the (left) front and (right) back of the NGVS after operation.

Thermal History Paint (THP) was applied by SCS to all the gas facing surfaces of the NGVS, which comprised three individual Nozzle Guide Vanes (NGVs). Also, four thermocouples were fitted, one at the leading edge of NGV 2 and one at the trailing edge of NGV 2, 3 and 4 (see Fig. 2). The component was installed and operated at VZLÚ in the engine test stand. Unfortunately an unrelated component failure caused the test to be stopped prematurely after approximately 6 minutes at constant load. After operation the segment was removed and there was no significant damage to the paint, as shown in Fig. 2. As expected, there were colour variations on the paint due to the temperature profile over the component. Hot spots can be identified visually, for example close to the hub the paint on the aerofoils appeared dark suggesting higher temperature.

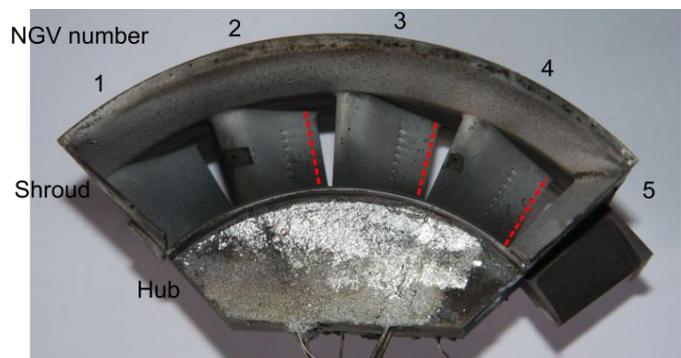
Figure 3. A photograph of the NGVS showing the locations of the measurements using THP on the trailing edges as red dashed lines.

The measurements recorded at the trailing edges on the pressure side of the NGVs (see Fig. 3) are provided in Fig. 4. The results show that there was a similar trend along the trailing edges of the different NGVs. The temperature decreased from the hub to the shroud. However, there was a significant difference in temperature between the different NGVs.
