# Thermal History Paint case study

## Nozzle Guide Vane Segment of small aircraft engine

The National Center for Research, Development and Testing of Aerospace in Prague, Czech Republic (Aerospace Research and Test Establishment - VZLÚ) together with the manufacturer of high-speed turbine machines for the aerospace, power and transport industries PBS Velka Bites developed a new design for a Nozzle Guide Vane Segment (NGVS) of a small jet engine. The purpose of the redesign was to overcome overheating of the components. A successful redesign extends the life of the components by avoiding burning of the trailing edges. The development included extensive testing using a dedicated test stand and was conducted as part of the ESPOSA<sup>1</sup>FP7 programme.

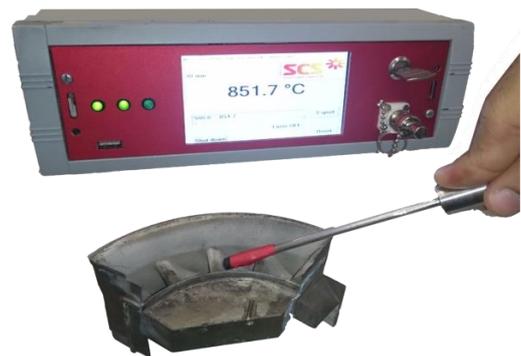
Figure 1. A measurement in action on the NGVS.

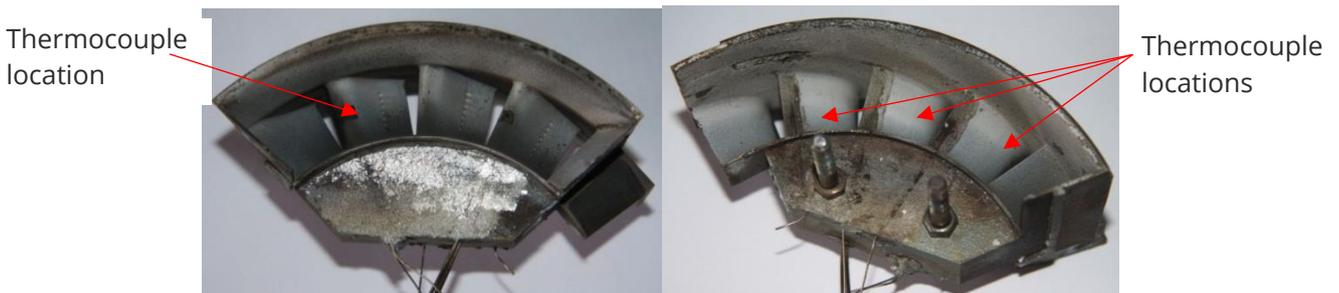
Thermal History Paint (THP) was applied by SCS to all the gas facing surfaces of the NGVS, which comprised three individual Nozzle Guide Vanes (NGVs). Also, four thermocouples were fitted, one at the leading edge of NGV 2 and one at the trailing edge of NGV 2, 3 and 4 (see Figure 2). The component was installed and operated at VZLÚ in the engine test stand. Unfortunately an unrelated component failure caused the test to be stopped prematurely after approximately 6 minutes at constant load. After operation the segment was removed and there was no significant damage to the paint, as shown in Figure 2. As expected, there were colour variations on the paint due to the temperature profile over the component. Hot spots can be identified visually, for example close to the hub the paint on the aerofoils appeared dark suggesting higher temperature.

Figure 2 A photograph of the (left) front and (right) back of the NGVS after operation.

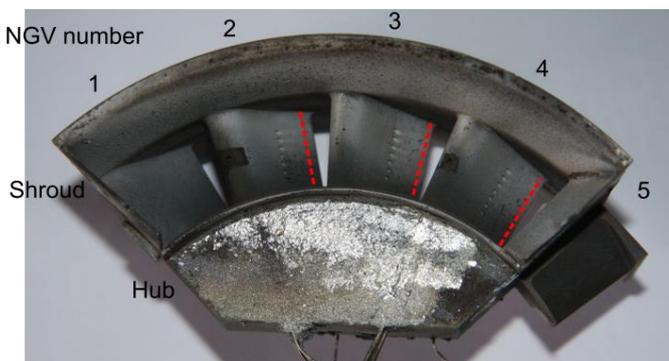
The measurements recorded at the trailing edges on the pressure side of the NGVs (see Figure 3) are provided in Figure . The results show that there was a similar trend along the trailing edges of the different NGVs. The temperature decreased from the hub to the shroud. However, there was a significant difference in temperature between the different NGVs.

trailing edges as red dashed lines.
